**HYDROGEOLOGICAL ASSESSMENT  
REPORT**

**271 MAIN STREET DEVELOPMENT**

**VILLAGE OF DUNDALK  
TOWNSHIP OF SOUTHGATE  
GREY COUNTY**

**C.F. CROZIER & ASSOCIATES INC.  
70 HURON STREET  
COLLINGWOOD, ON L9Y 4L4**

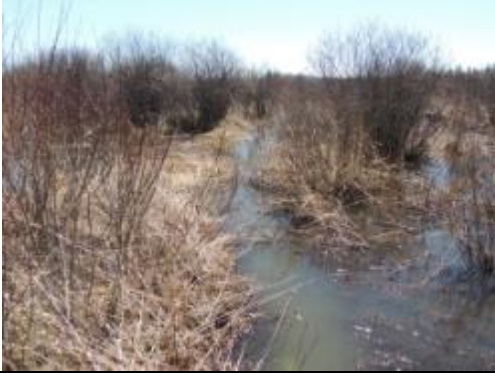
**Table 2: Channel Conditions through Meadow Marsh and Deciduous Swamp**

| Date of Observation | Observations | Representative Photos |
|---|---|---|
| April 26, 2018 | <ul style="list-style-type: none"> <li>• Water gently flowing to northwest through deciduous swamp</li> <li>• Standing water in meadow marsh (photo)</li> </ul> | |
| May 25, 2018 | <ul style="list-style-type: none"> <li>• Standing water in channel through swamp; no discernible flow</li> </ul> | |
| July 24, 2018 | <ul style="list-style-type: none"> <li>• Standing water only in deeper sections of channel extending through meadow marsh and swamp</li> </ul> | |

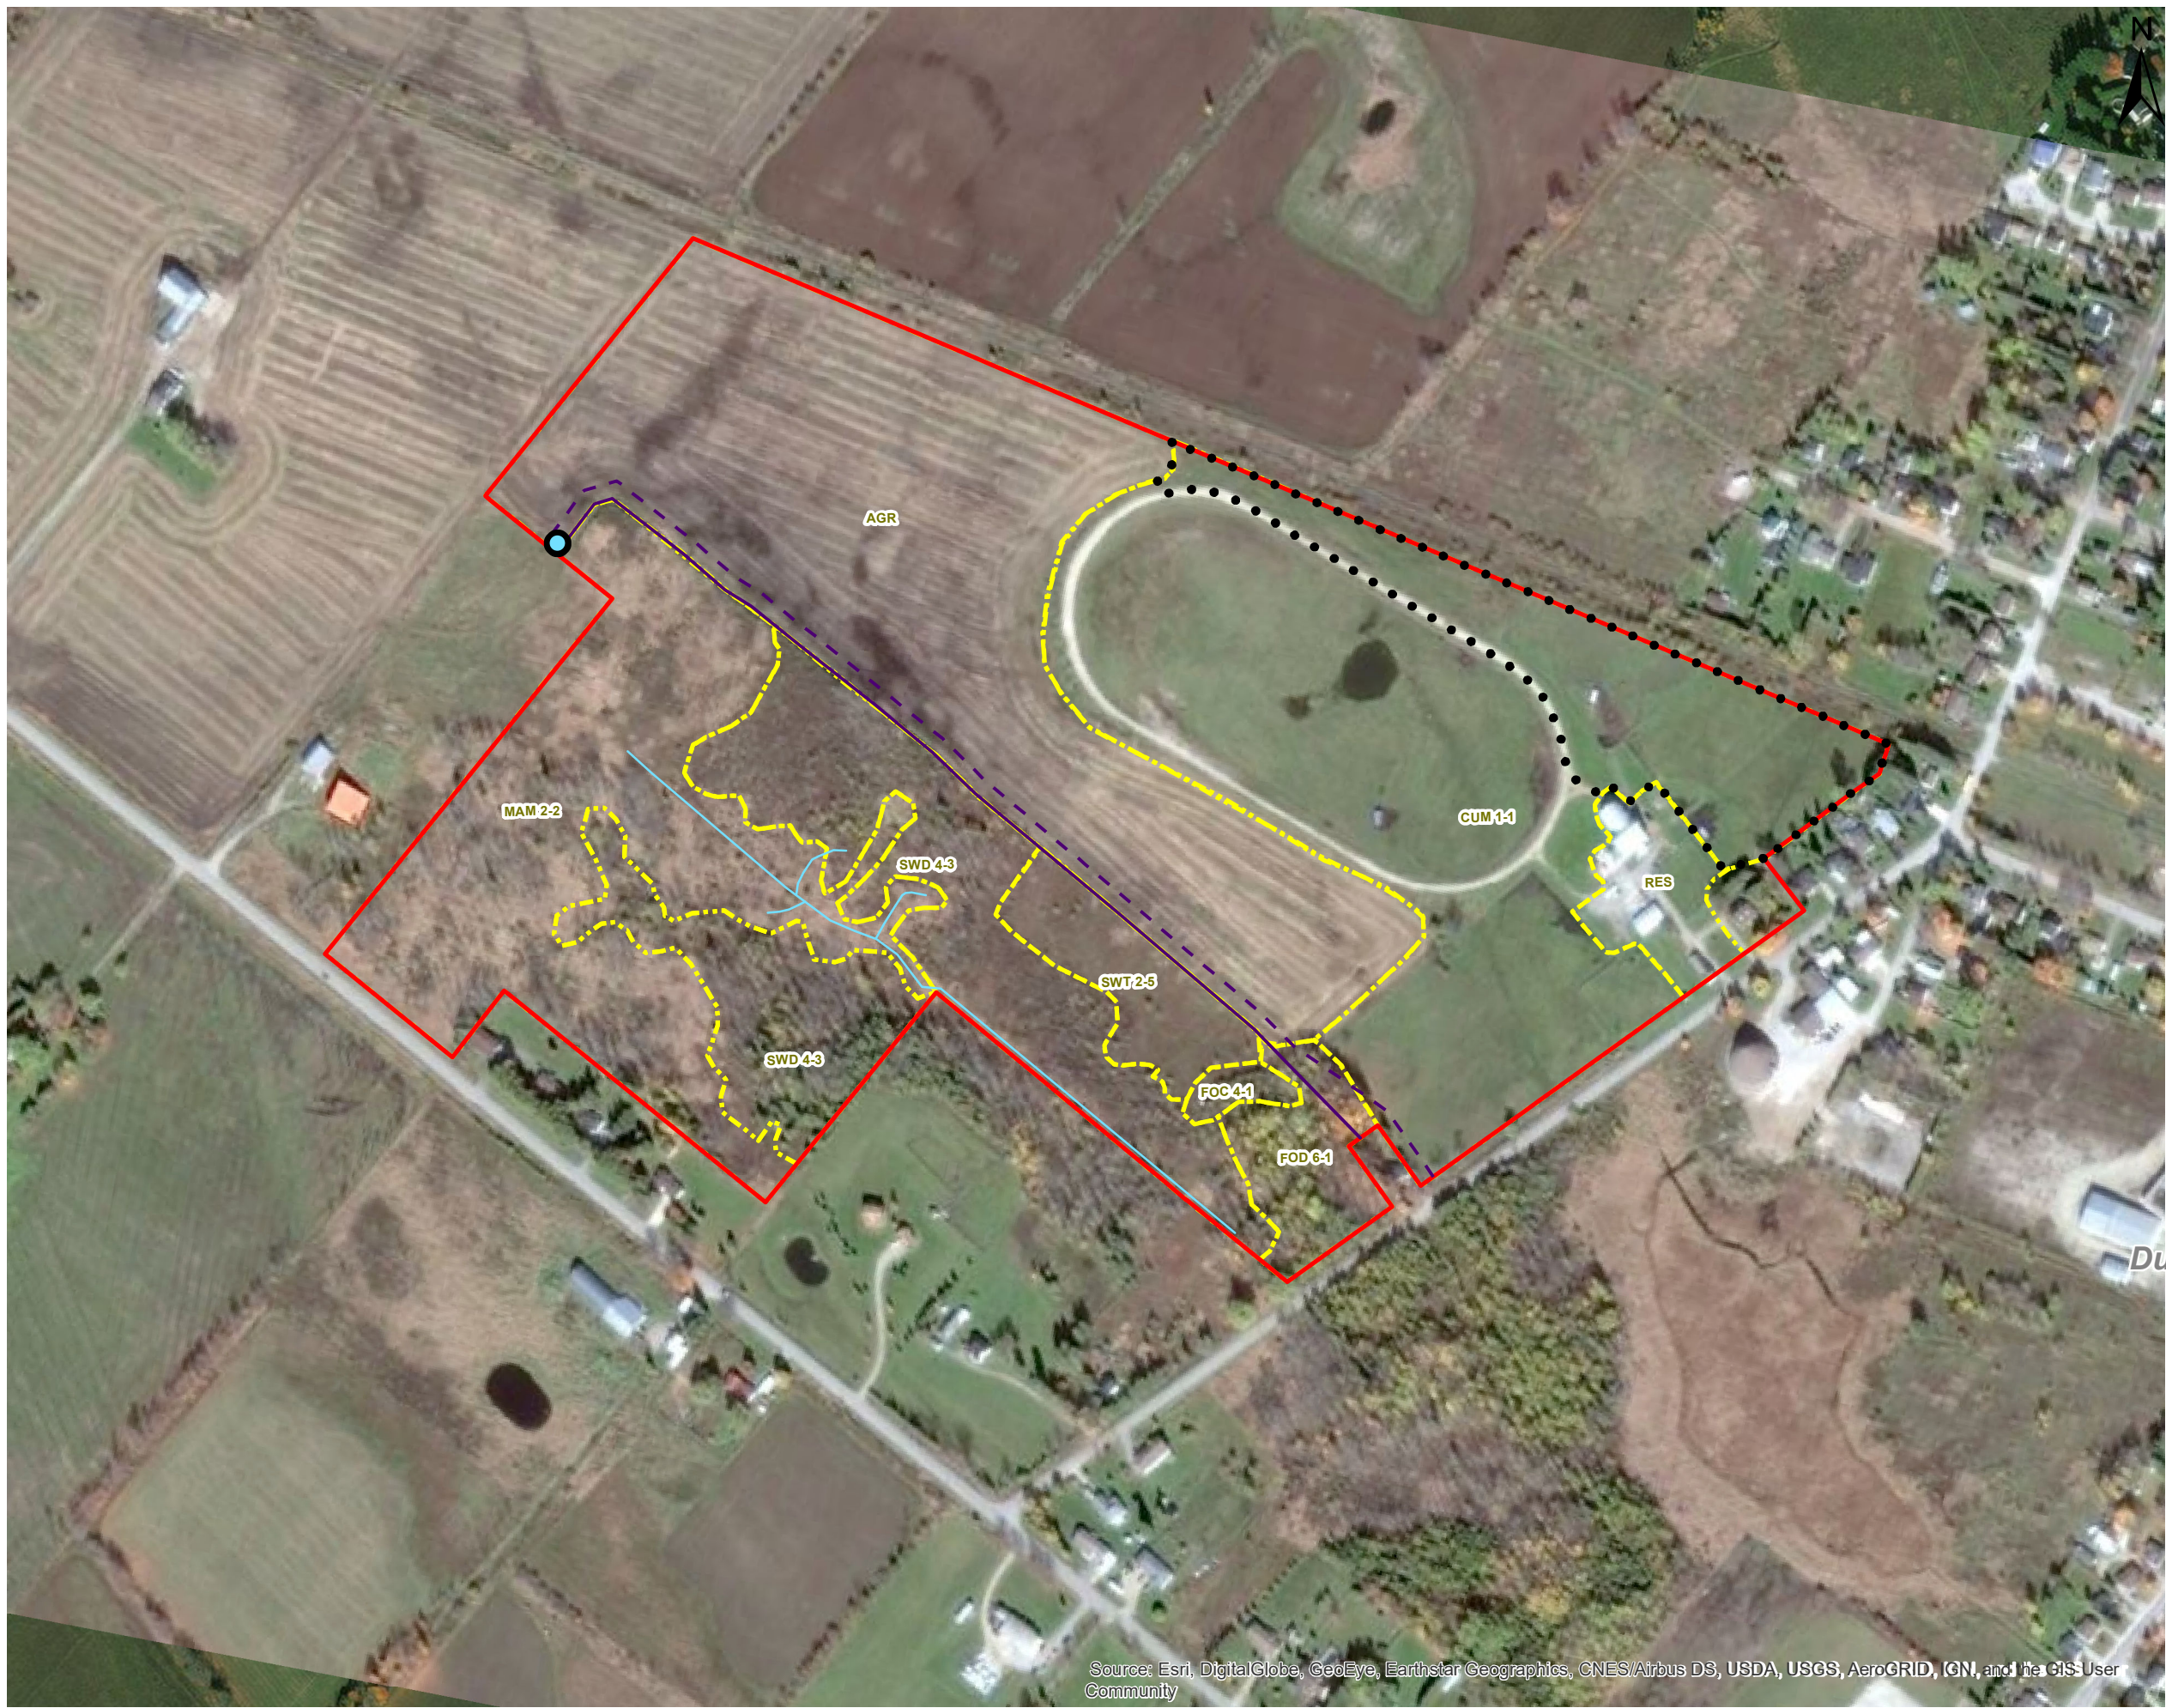
- Property Boundary
- Tile Drain Outlet
- Drain
- Staked Dripline (Schaeffer Dzaldov Bennett Ltd., Staked June 25, 2018)
- Wetland and Dripline Buffer (10m)
- Grasshopper Sparrow (CUM)(2017)
- CUM1-1 Put Into Agricultural Production in 2018

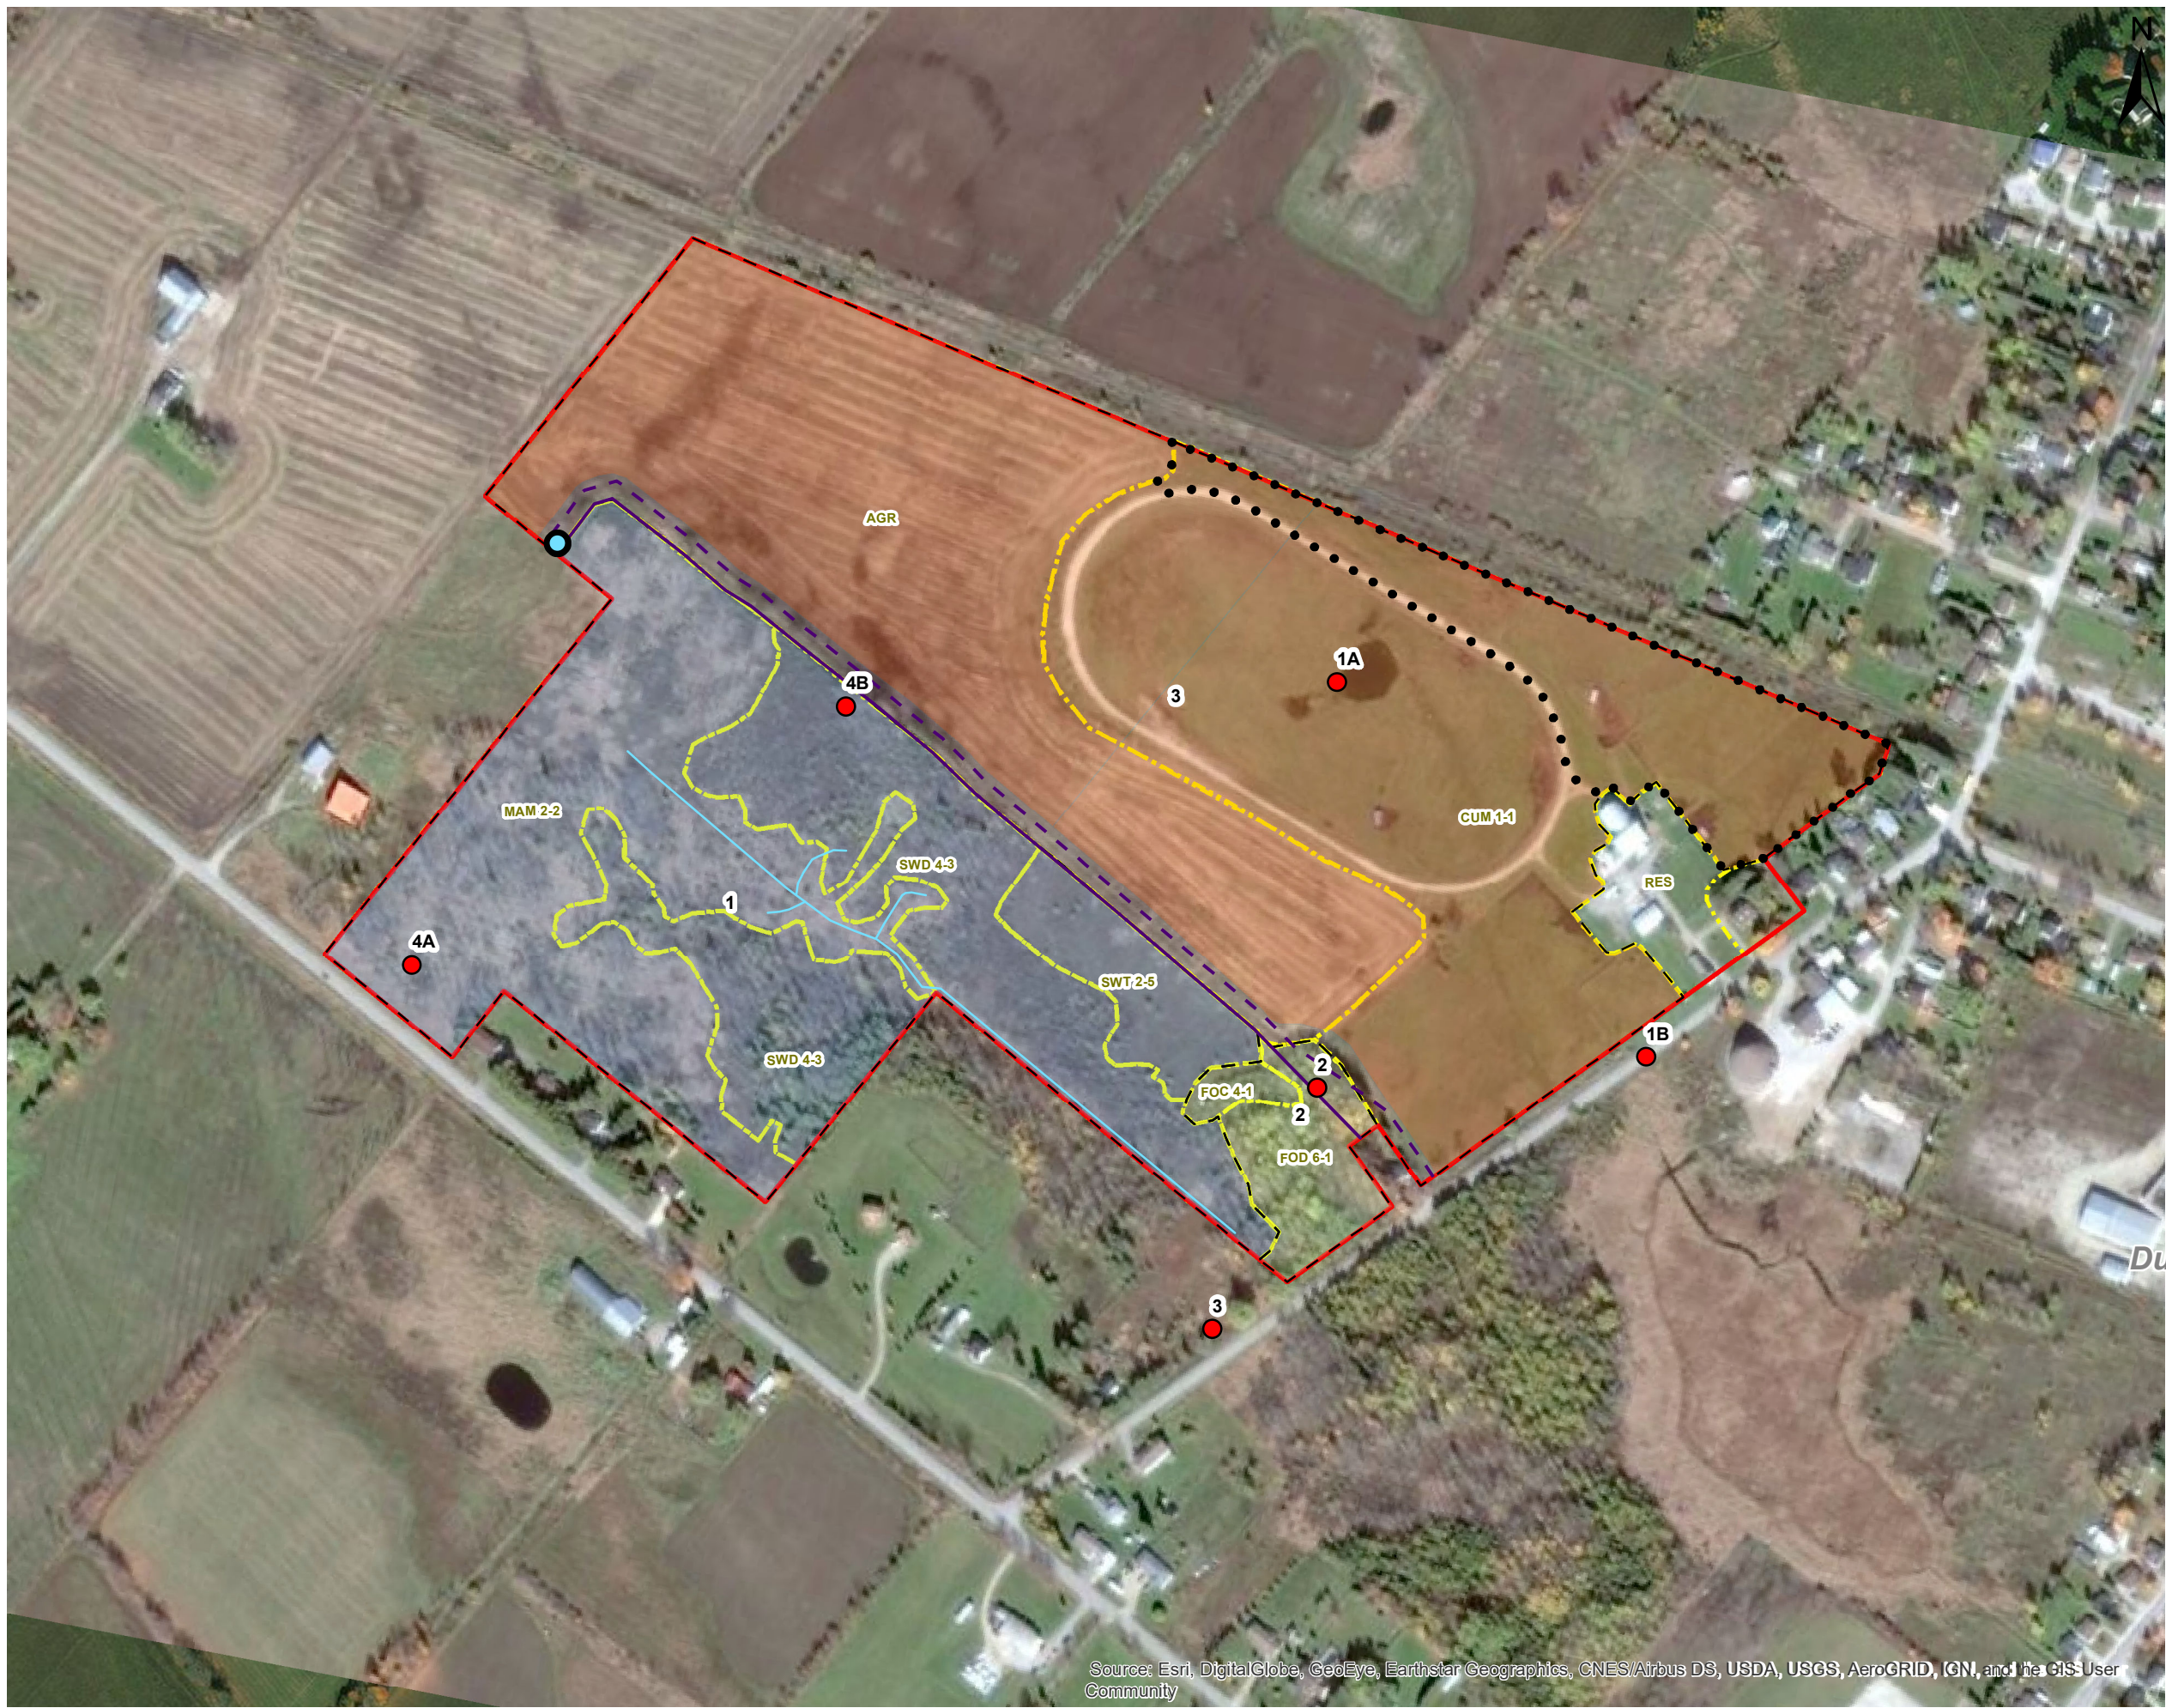
- Property Boundary
- Amphibian Survey Stations (2017)
- Tile Drain Outlet
- Drain
- Staked Dripline (Schaeffer Dzaldov Bennett Ltd., Staked June 25, 2018)
- Wetland and Dripline Buffer (10m)
- Grasshopper Sparrow (CUM)(2017)
- Wildlife Units (Breeding Birds)(2017)
- CUM1-1 Put Into Agricultural Production in 2018

Formal surveys were undertaken for birds and amphibians during the time at one of their most vulnerable life cycle stages: breeding. It is at this time that they are anchored to breeding activity (nests, breeding ponds) that they migrate from when breeding is complete. These species inform the functions of landscape feature in terms of diversity, species richness and the importance of the underlying vegetation and water resources that support wildlife habitat. The wildlife units that were sampled, together with stations for amphibian calling counts are illustrated on Figure 3.

Amphibian breeding habitat is limited to the western portion of the property consistent with the wetlands. Four locations were surveyed at the edges of the thicket swamp and treed swamp, and also at the meadow marsh south of Glenelg (Figure 2).

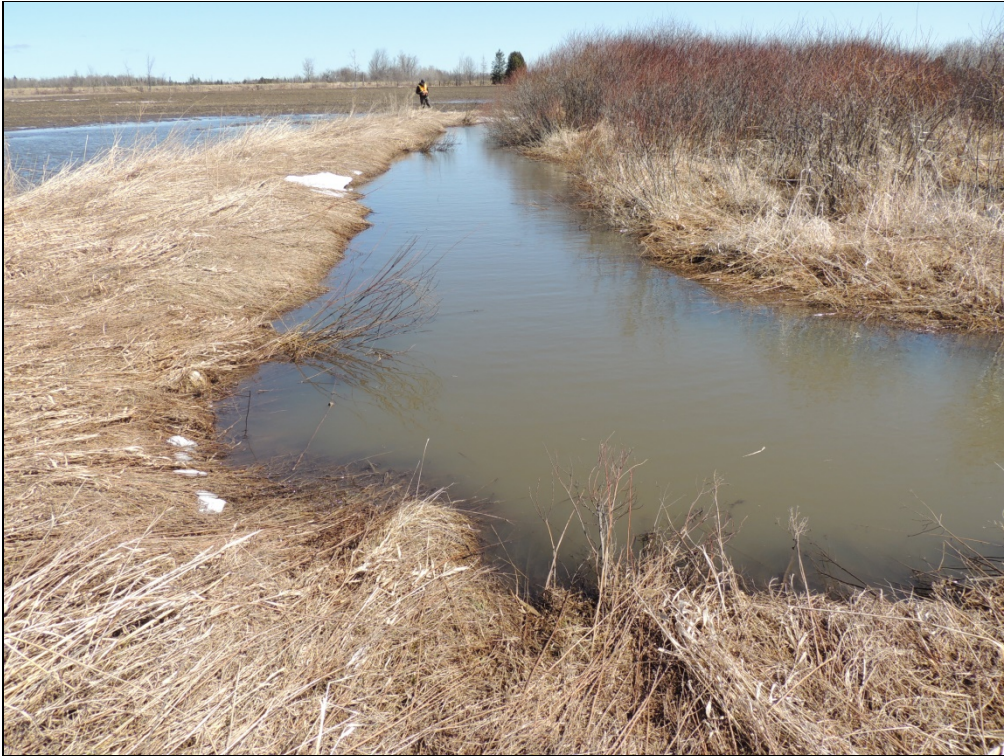
Photograph 3. Drainage feature within swamp thicket (April 2018).

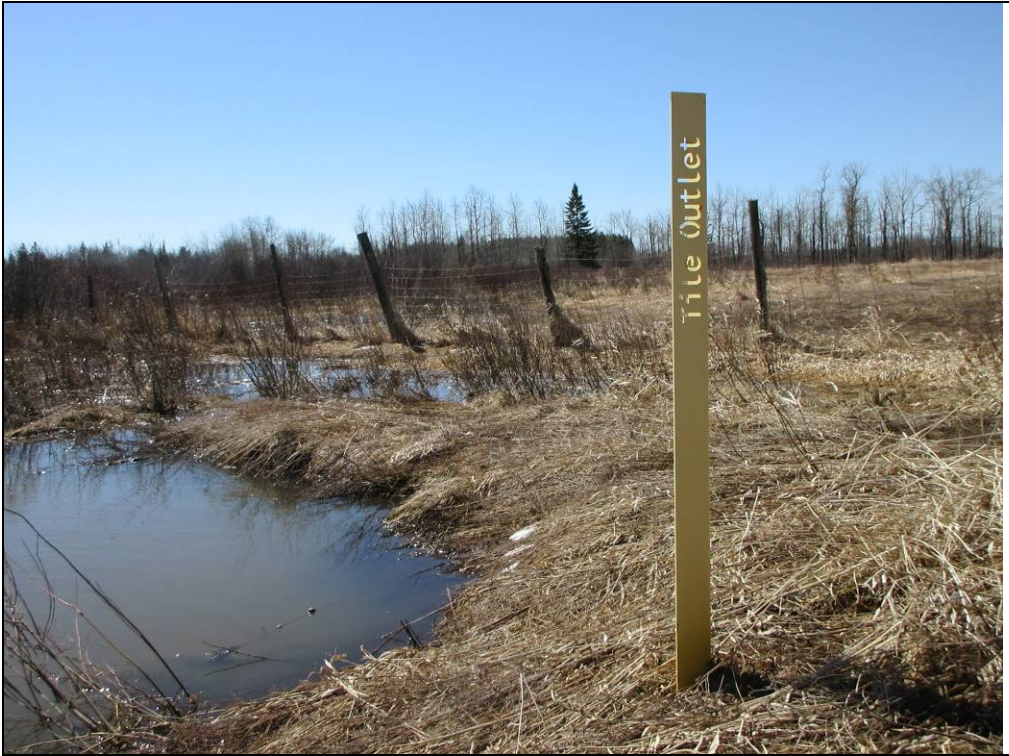
Photograph 13. Tile outlet mostly northerly limits of the property (May 2018).

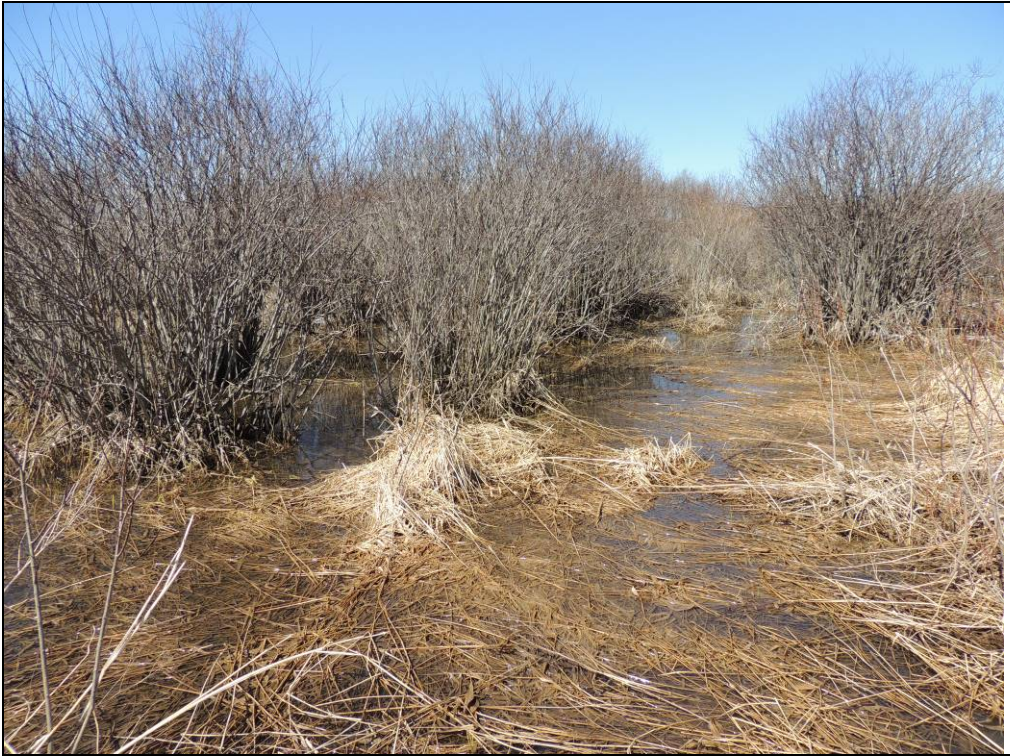
Photograph 14. Spring Freshet of drainage feature. Representative of how the channels are braided and difficult to define (April 2018).

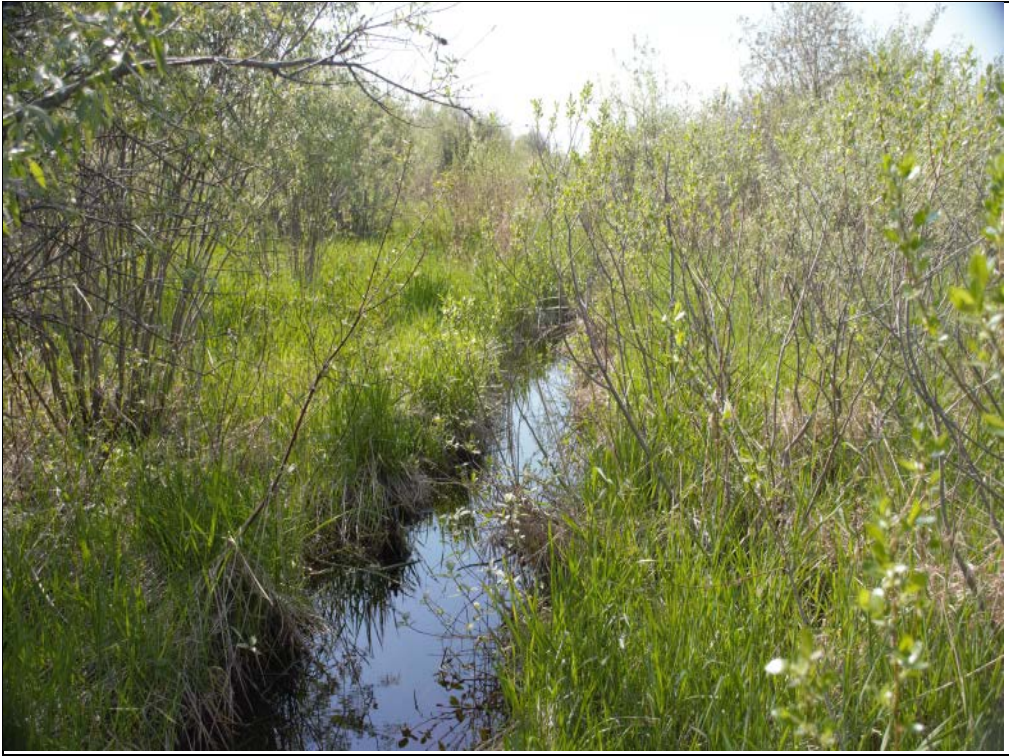
Photograph 15. Channelized drainage within swamp thicket along west property limits (May, 2018).

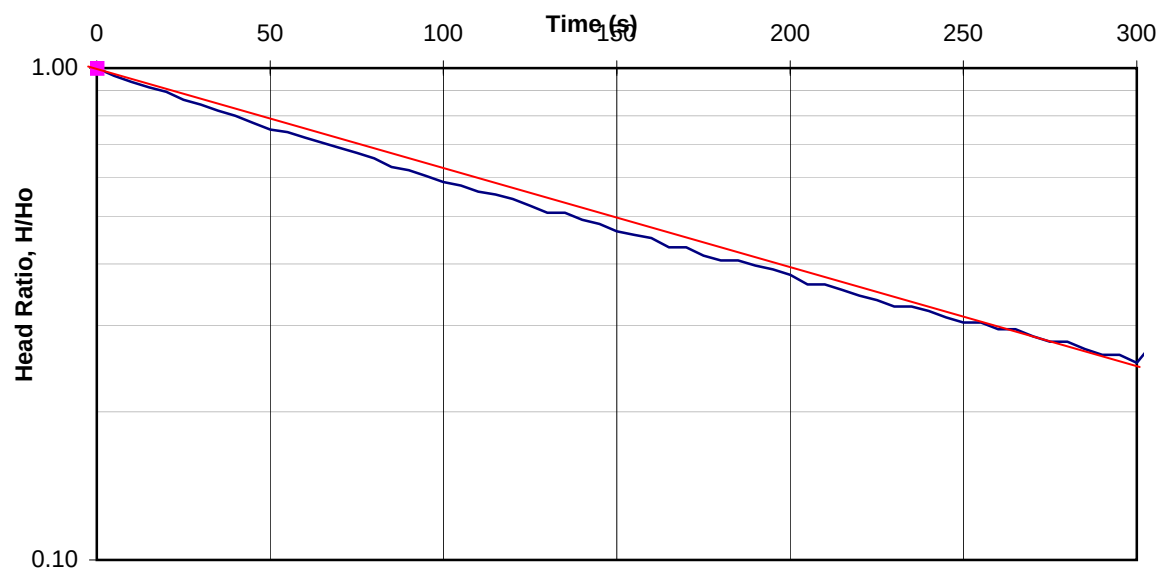
### Falling Head Test (Slug Test)

Test Date: 27-Aug-15  
 Piezometer/Well No.: BH/MW 102  
 Ground level: 518.80 m  
 Screen top level: 515.40 m  
 Screen bottom level: 512.40 m  
 Test El. (at midpoint of screen): 513.9 m  
 Test depth (at midpoint of screen): 4.9 m  
 Screen length L= 3 m  
 Diameter of undisturbed portion c 2R= 0.22 m  
 Standpipe diameter 2r= 0.05 m  
 Initial unbalanced head Ho= -0.417 m  
 Initial water depth 2.37 m  
 Aquifer material: **Silty Clay, Till**  
 2 x 3.14 x L  
 Shape factor F=  $\frac{2 \times 3.14 \times L}{\ln(L/R)}$  = 5.701815 m  
 Permeability K=  $\frac{3.14 \times r^2}{F \times (t_2 - t_1)} \times \ln(H_1/H_2)$  (Bouwer and Rice Method)  
 $\frac{\ln(H_1/H_2)}{(t_2 - t_1)} = 0.001679069$   
 K= **5.8E-05 cm/s**  
**5.8E-07 m/s**

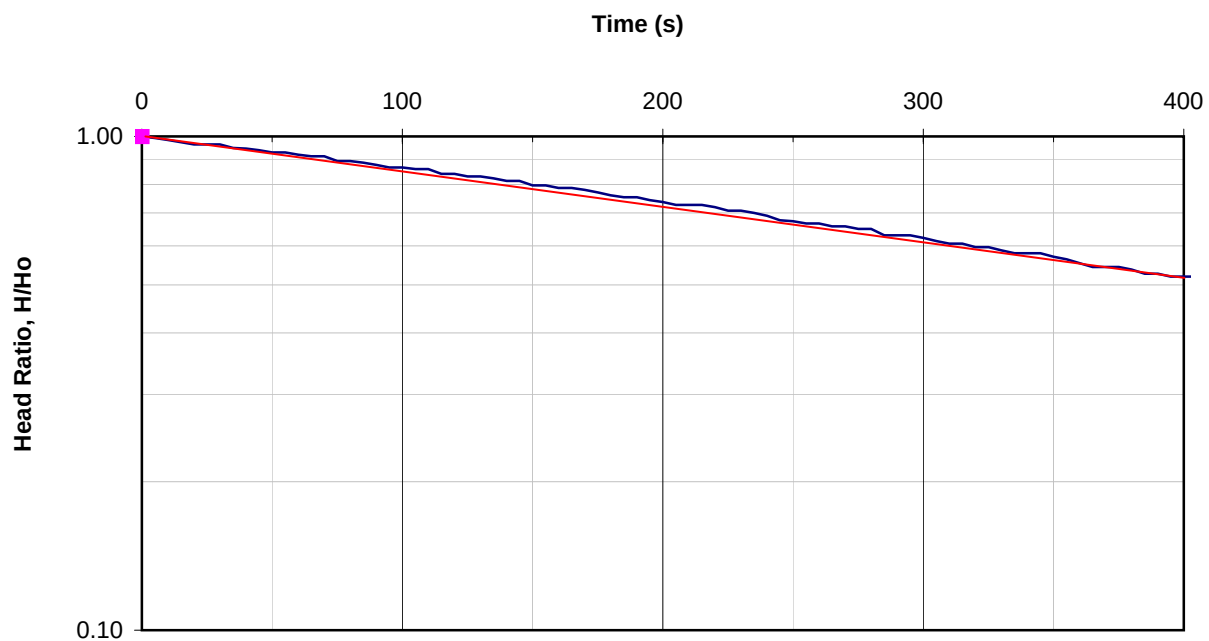
### Falling Head Test (Slug Test)

Test Date: 27-Aug-15  
 Piezometer/Well No.: BH/MW 103 D  
 Ground level: 515.38 m  
 Screen top level: 513.48 m  
 Screen bottom level: 511.98 m  
 Test El. (at midpoint of screen): 512.73 m  
 Test depth (at midpoint of screen): 2.65 m  
 Screen length L= 1.5 m  
 Diameter of undisturbed portion c 2R= 0.22 m  
 Standpipe diameter 2r= 0.05 m  
 Initial unbalanced head Ho= -0.483 m  
 Initial water depth 0.56 m  
 Aquifer material: **Silty Clay Till**  
 2 x 3.14 x L  
 Shape factor F=  $\frac{2 \times 3.14 \times L}{\ln(L/R)}$  = 3.607239 m  
 Permeability K=  $\frac{3.14 \times r^2}{F \times (t_2 - t_1)} \times \ln(H_1/H_2)$  (Bouwer and Rice Method)  
 $\frac{\ln(H_1/H_2)}{(t_2 - t_1)} = 0.001801004$   
 K= **9.8E-05 cm/s**  
**9.8E-07 m/s**

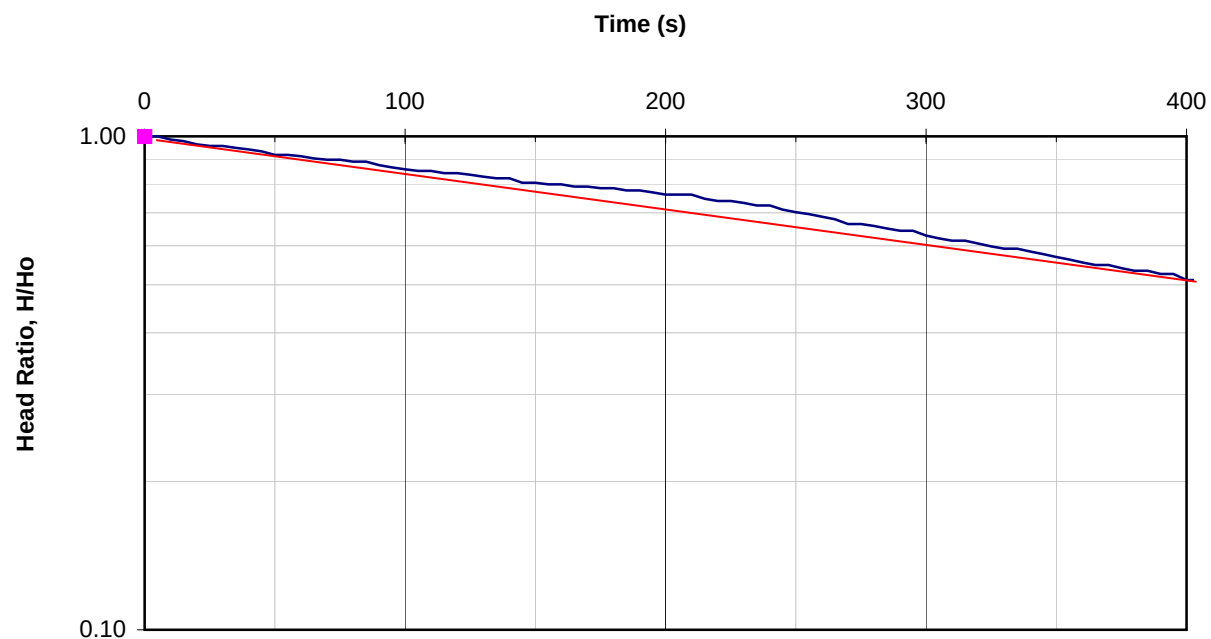
Falling Head Test (Slug Test)

Test Date: 27-Aug-15  
Piezometer/Well No.: BH/MW 104  
Ground level: 516.24 m  
Screen top level: 512.84 m  
Screen bottom level: 509.84 m  
Test El. (at midpoint of screen): 511.34 m  
Test depth (at midpoint of screen): 4.9 m  
Screen length L= 3 m

K= **1.2E-05 cm/s**  
**1.2E-07 m/s**

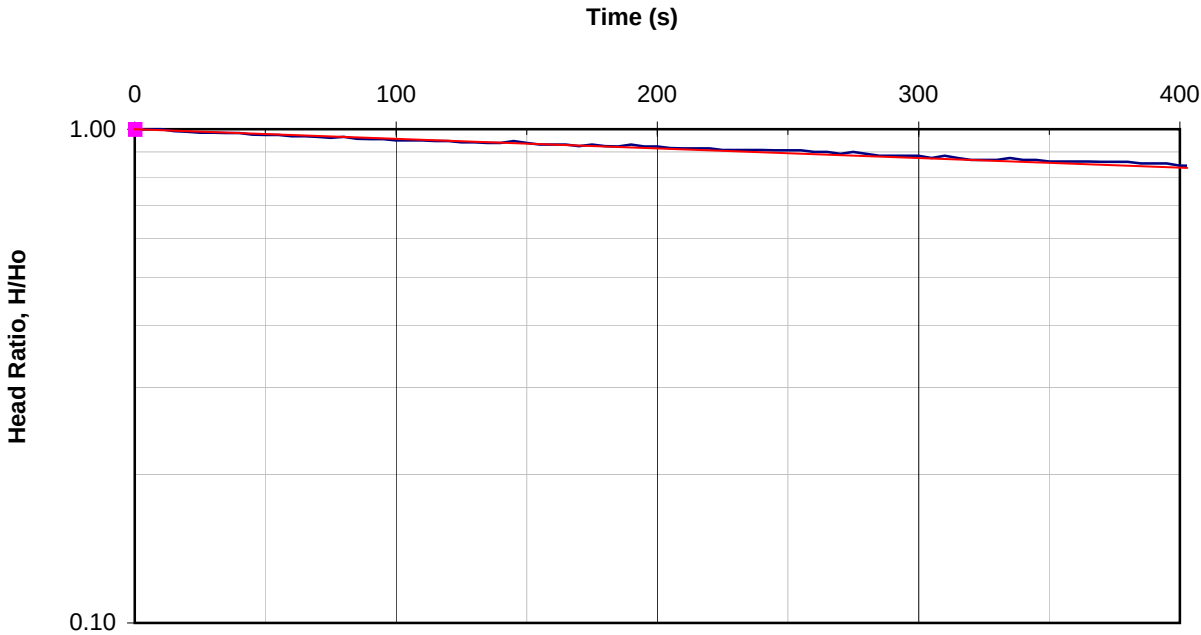
### Falling Head Test (Slug Test)

Test Date: 27-Aug-15  
 Piezometer/Well No.: BH/MW 105  
 Ground level: 516.43 m  
 Screen top level: 513.03 m  
 Screen bottom level: 510.03 m  
 Test El. (at midpoint of screen): 511.53 m  
 Test depth (at midpoint of screen): 4.9 m  
 Screen length L= 3 m  
 Diameter of undisturbed portion c 2R= 0.22 m  
 Standpipe diameter 2r= 0.05 m  
 Initial unbalanced head Ho= -0.526 m  
 Initial water depth 1.01 m  
 Aquifer material: **Silty Clay Till**  
 2 x 3.14 x L  
 Shape factor F=  $\frac{2 \times 3.14 \times L}{\ln(L/R)}$  = 5.701815 m  
 Permeability K=  $\frac{3.14 \times r^2}{F \times (t_2 - t_1)} \times \ln(H_1/H_2)$  (Bouwer and Rice Method)

K= **5.3E-06 cm/s**  
**5.3E-08 m/s**

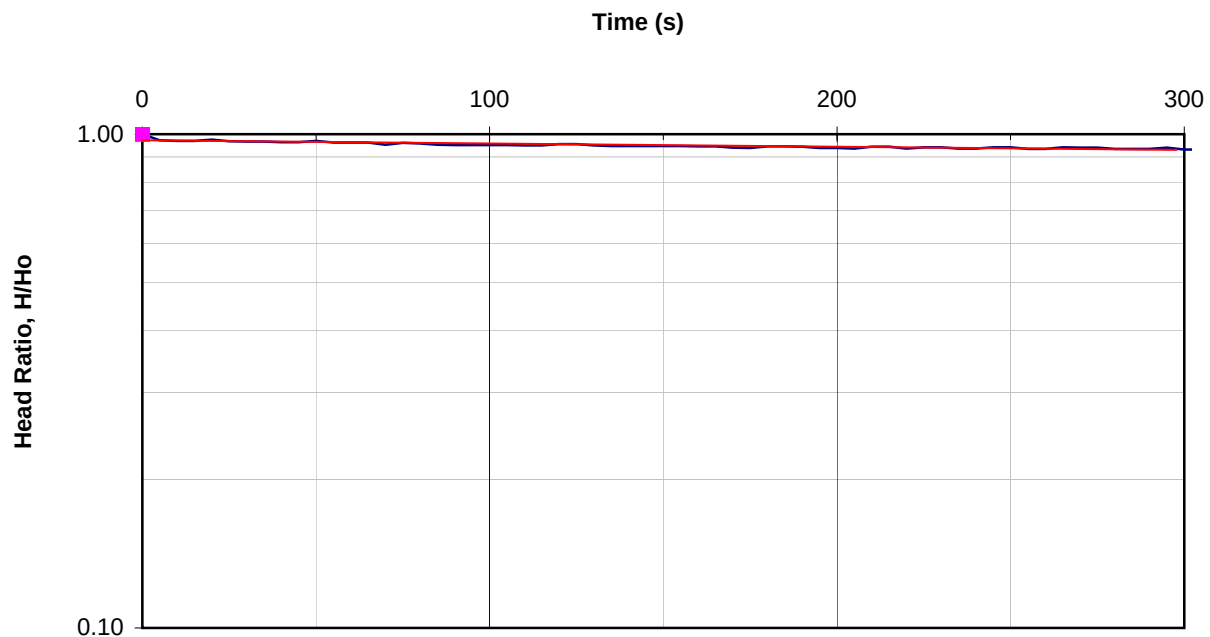
**Falling Head Test (Slug Test)**

Test Date: 27-Aug-15  
 Piezometer/Well No.: BH/MW 106 D  
 Ground level: 513.19 m  
 Screen top level: 509.79 m  
 Screen bottom level: 506.79 m  
 Test El. (at midpoint of screen): 508.29 m  
 Test depth (at midpoint of screen): 4.9 m  
 Screen length L= 3 m  
 Diameter of undisturbed portion c 2R= 0.22 m  
 Standpipe diameter 2r= 0.05 m  
 Initial unbalanced head Ho= -0.491 m  
 Initial water depth 2.06 m  
 Aquifer material: **Silty Clay Till**  
 2 x 3.14 x L  
 Shape factor F=  $\frac{2 \times 3.14 \times L}{\ln(L/R)}$  = 5.701815 m  
 Permeability K=  $\frac{3.14 \times r^2}{F \times (t_2 - t_1)} \times \ln(H_1/H_2)$  (Bouwer and Rice Method)

K= **1.3E-05 cm/s**  
**1.3E-07 m/s**

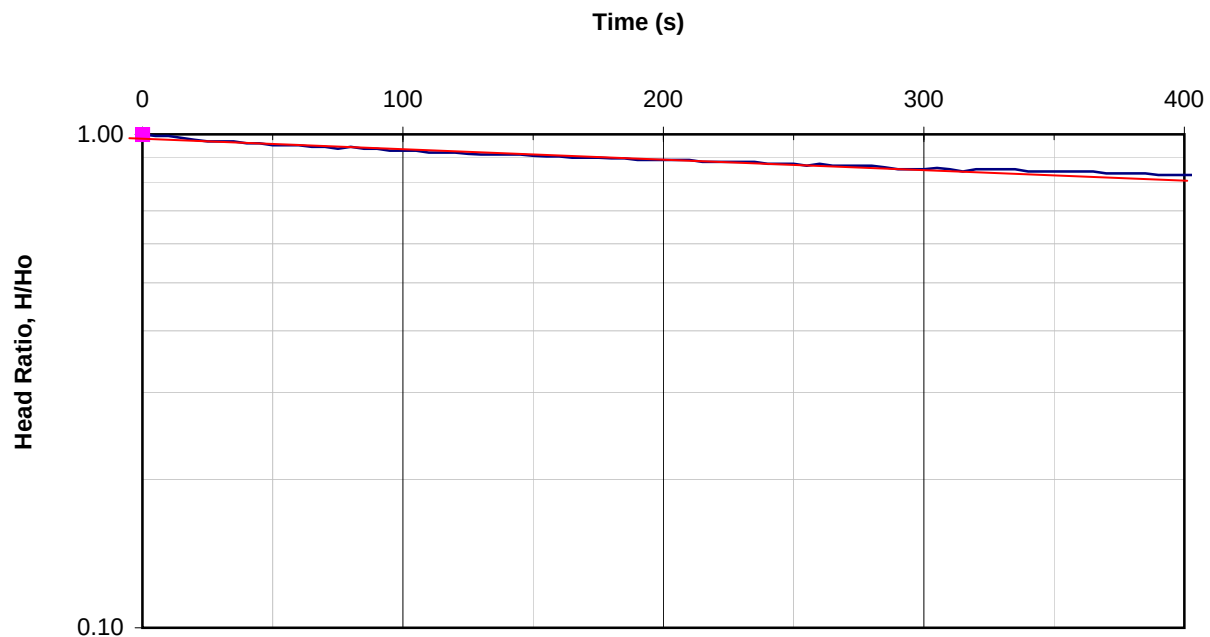
**Falling Head Test (Slug Test)**

Test Date: 27-Aug-15  
 Piezometer/Well No.: BH/MW 107D  
 Ground level: 513.54 m  
 Screen top level: 510.14 m  
 Screen bottom level: 507.14 m  
 Test El. (at midpoint of screen): 508.64 m  
 Test depth (at midpoint of screen): 4.9 m  
 Screen length L= 3 m  
 Diameter of undisturbed portion c 2R= 0.22 m  
 Standpipe diameter 2r= 0.05 m  
 Initial unbalanced head Ho= -0.489 m  
 Initial water depth 0.56 m  
 Aquifer material: **Silty Clay Till**  
 2 x 3.14 x L  
 Shape factor F=  $\frac{2 \times 3.14 \times L}{\ln(L/R)}$  = 5.701815 m  
 Permeability K=  $\frac{3.14 \times r^2}{F \times (t_2 - t_1)} \times \ln(H_1/H_2)$  (Bouwer and Rice Method)

K= **2.6E-05 cm/s**  
**2.6E-07 m/s**

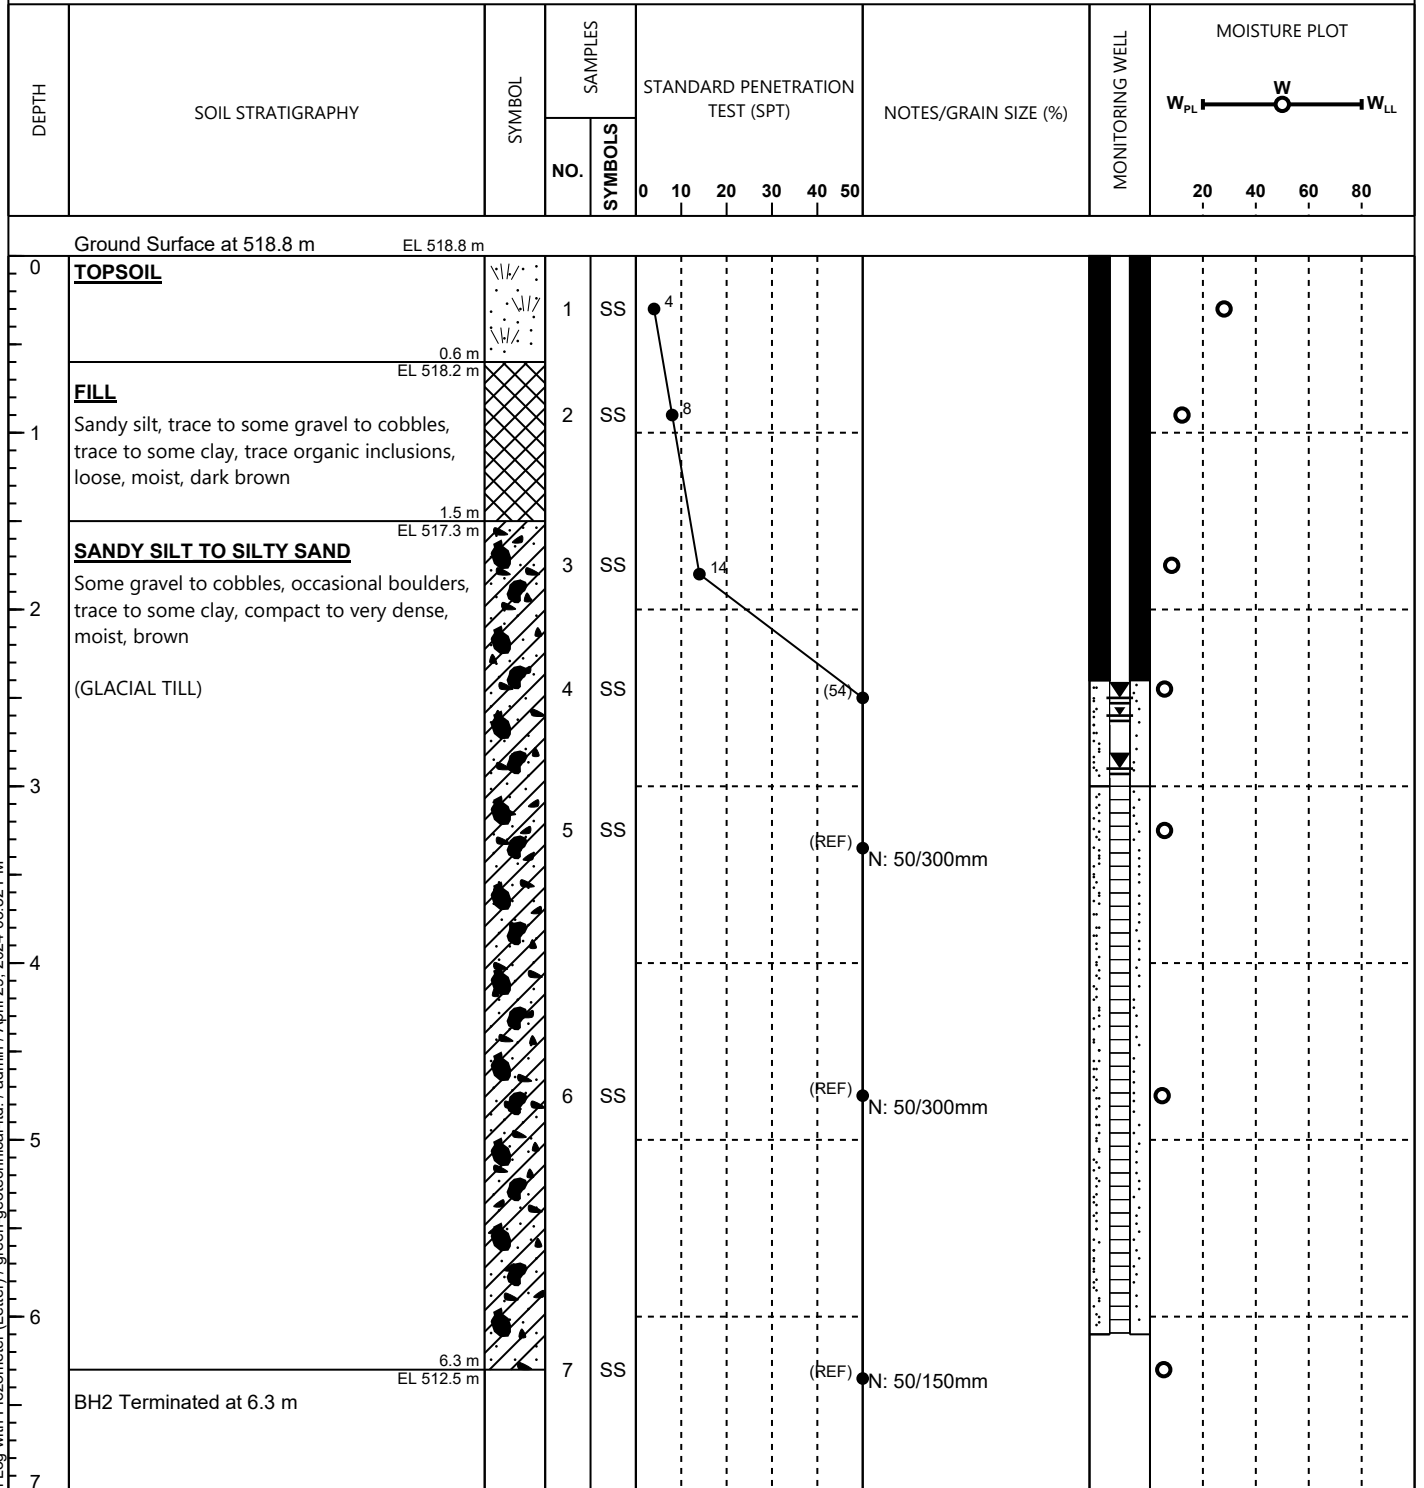
Borehole was dry and open upon completion of drilling. Stabilized water level measured at 2.6 mbg (elev. 516.2 m) on 01-06-24 by Green Geo. Stabilized water level measured at 2.9 mbg (elev 515.9 m) on 12-13-23 and 2.5 mbg (elev. 516.3 m) on 03-13-24 by Crozier.

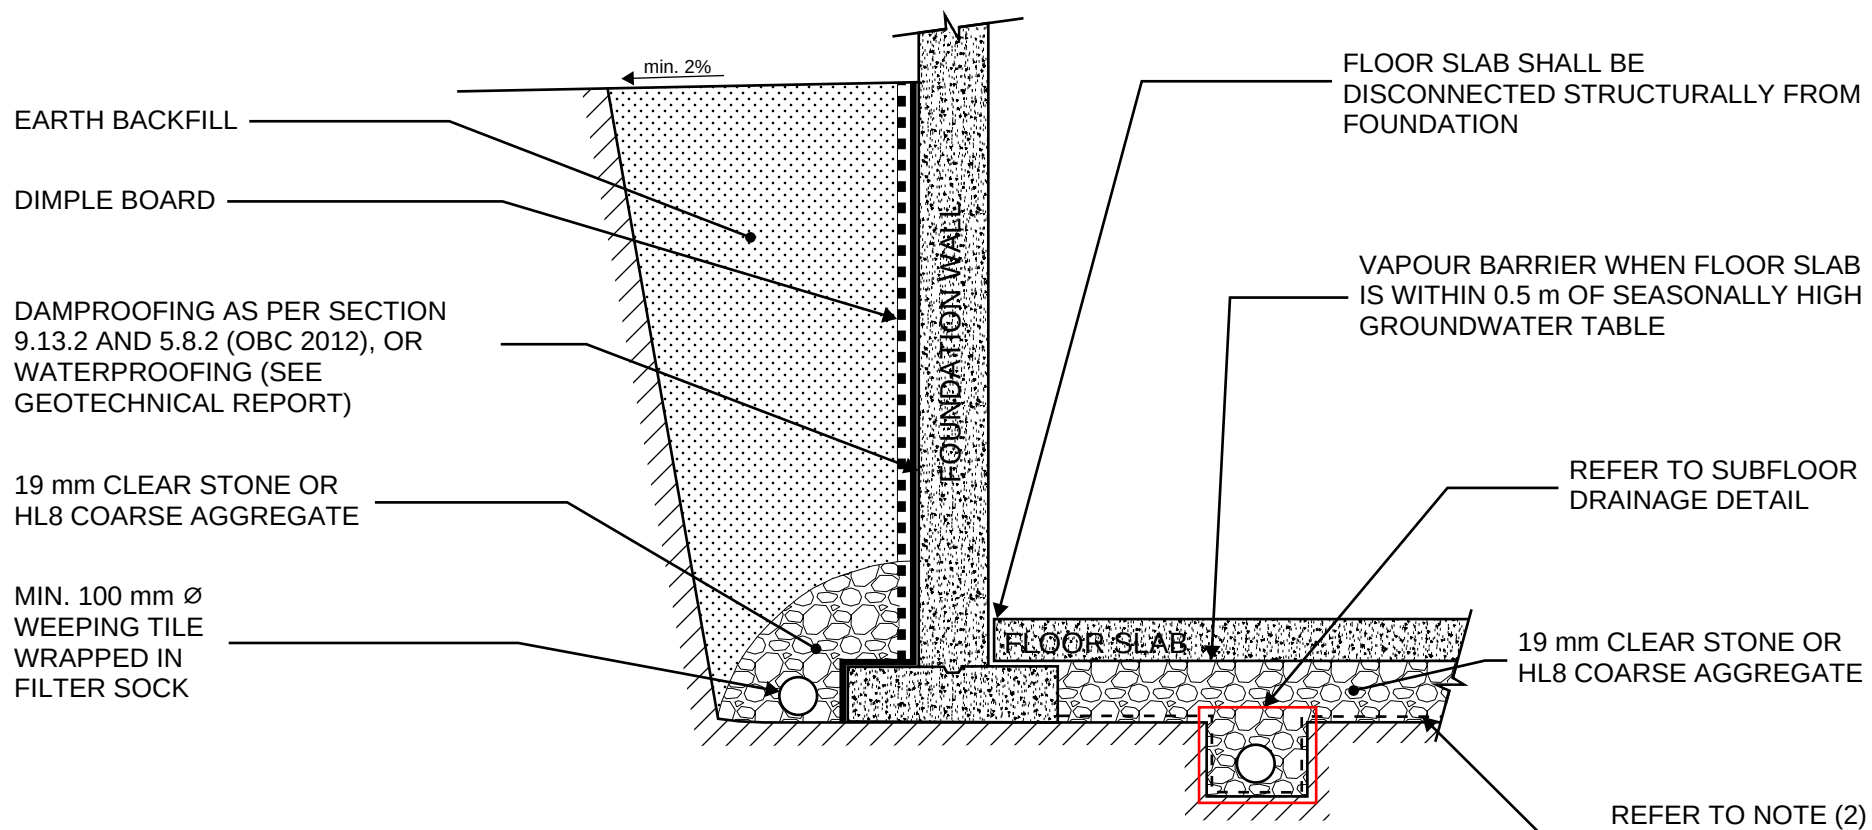
1. TYPICAL SCHEMATIC ONLY. MUST BE READ IN CONJUNCTION WITH GEOTECHNICAL REPORT.
2. WHEN THE SUBGRADE CONSISTS OF COHESIONLESS SOIL, IT MUST BE SEPARATED FROM THE SUBFLOOR DRAINAGE LAYER USING A NON-WOVEN GEOTEXTILE (TERRAFIX 360R OR EQUIVALENT)
3. NOT TO SCALE

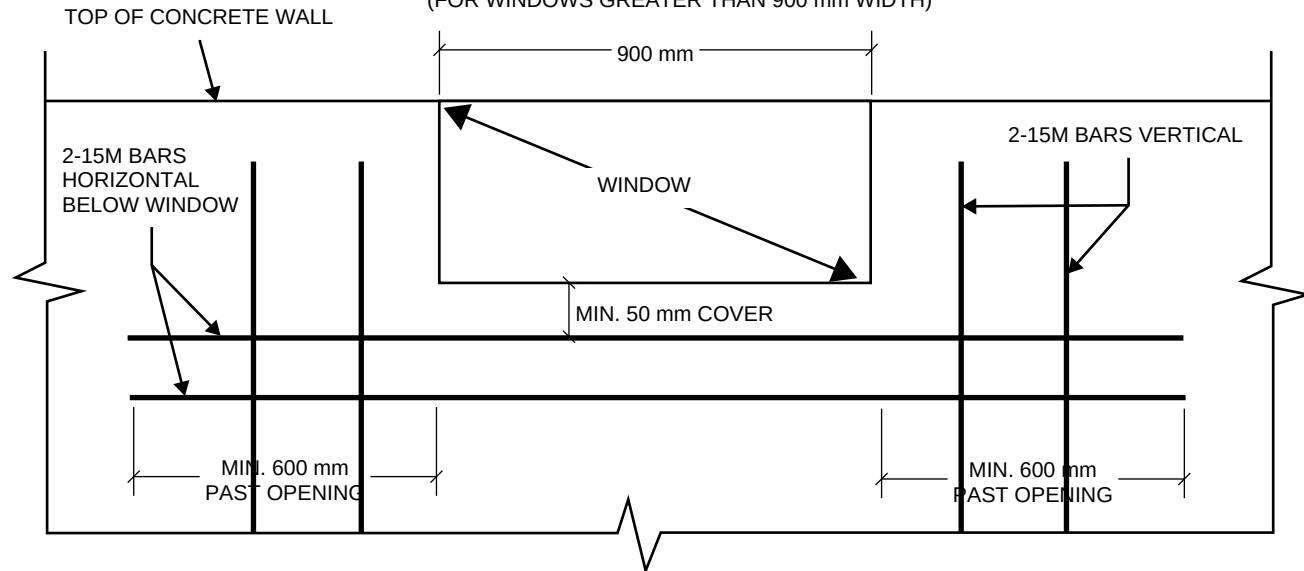
(FOR WINDOWS GREATER THAN 900 mm WIDTH)

1. REINFORCING STEEL C.S.A G30.18-09 GRADE 400
2. CONCRETE MINIMUM 28 DAY STRENGTH 20 MPa
3. BASE OF ALL FOOTING EXCAVATION TO BE INSPECTED AND APPROVED PRIOR TO PLACING FORMWORK
4. TO BE USED IN CONJUNCTION WITH STRUCTURAL REPORT
5. DRAWINGS ARE NOT TO SCALE
