**HYDROGEOLOGICAL ASSESSMENT  
REPORT**

**271 MAIN STREET DEVELOPMENT**

**VILLAGE OF DUNDALK  
TOWNSHIP OF SOUTHGATE  
GREY COUNTY**

**C.F. CROZIER & ASSOCIATES INC.  
70 HURON STREET  
COLLINGWOOD, ON L9Y 4L4**

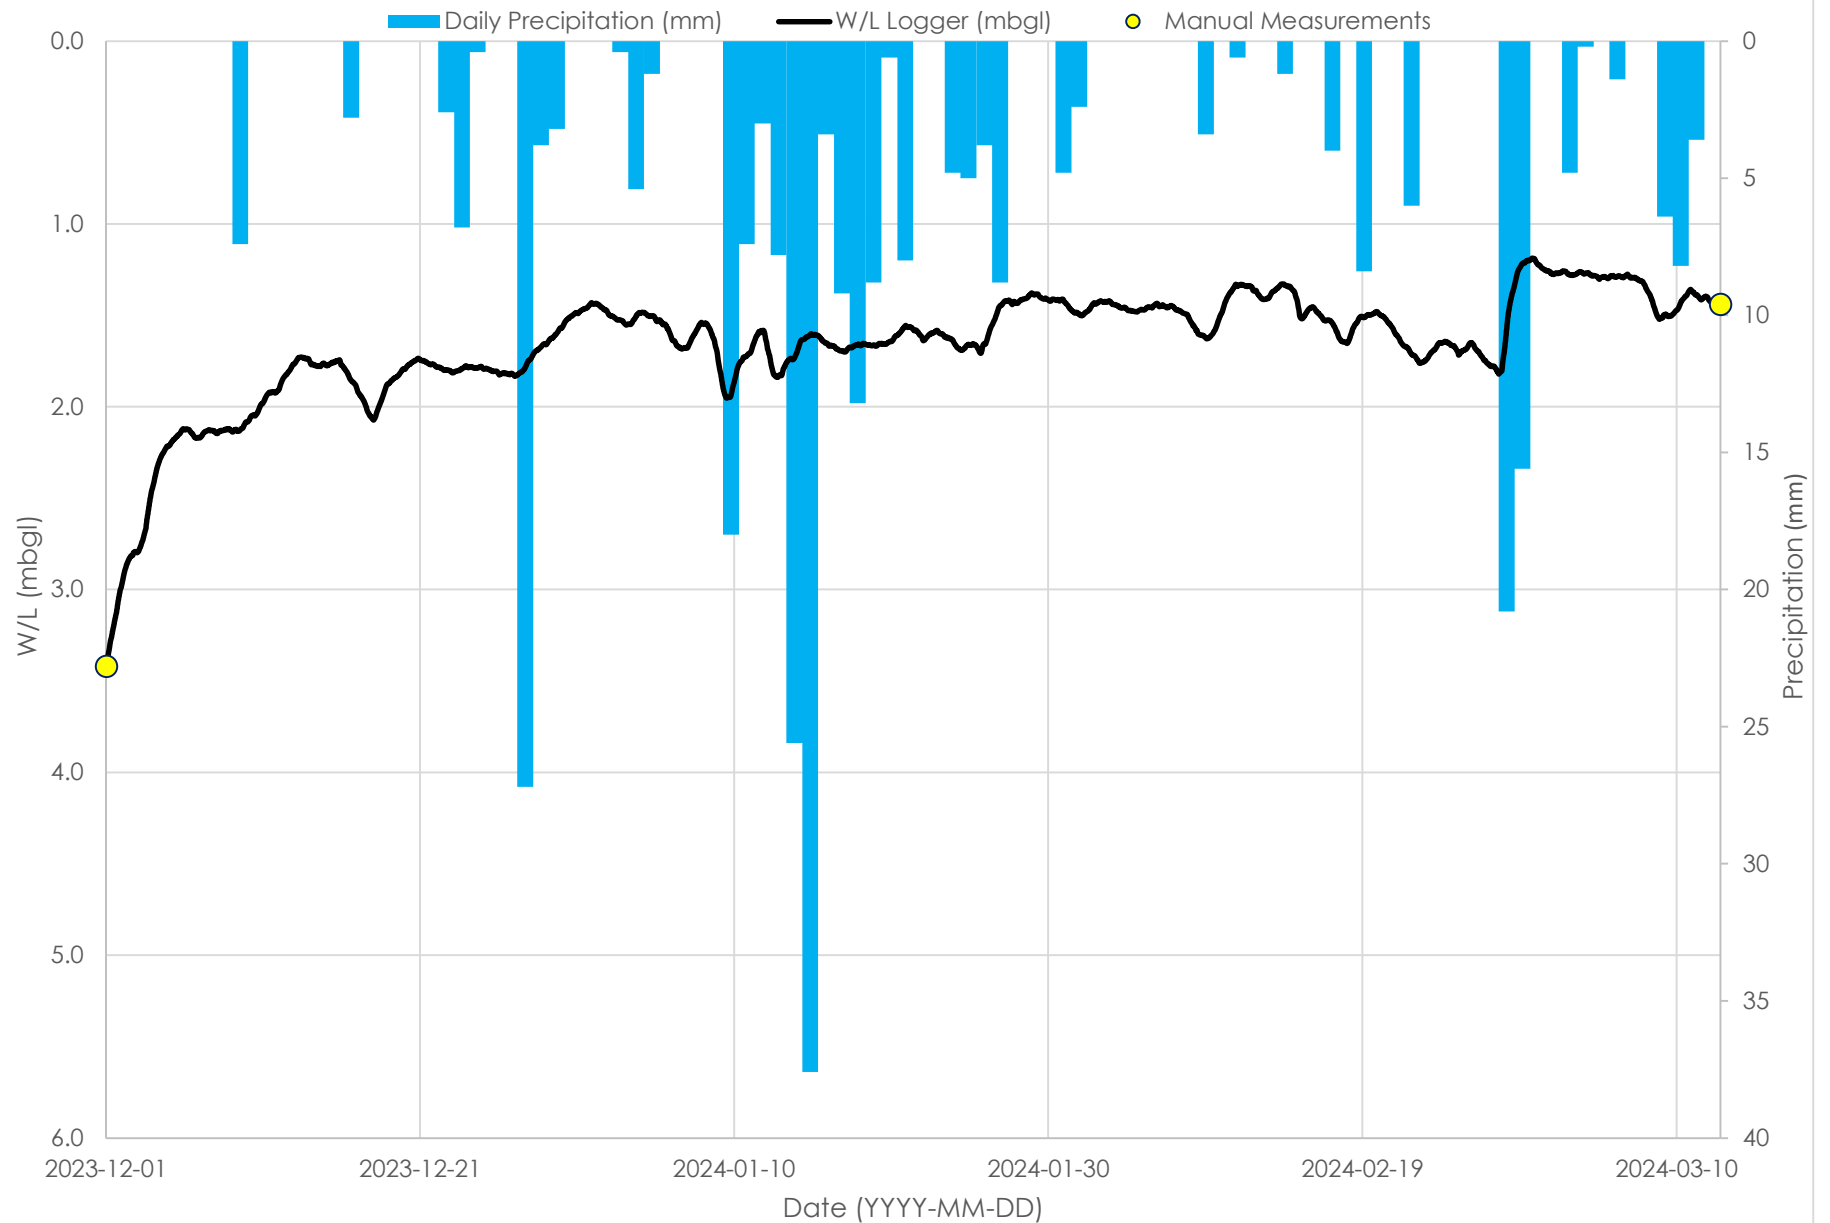
# MW23-1 - 271 Main Street East, Dundalk

Hydrographs were also developed for the two monitoring wells and the groundwater elevations were reviewed. Seasonal highs of 1.19 mbgl and 2.22 mbgl for MW23-1 and MW23-2, respectively, were noted on March 1, 2024. At the time of this report, monitoring has been completed from December 1, 2023 to March 13, 2024. Throughout this time, lows were noted in December for both monitoring wells, and each well showed a moderate response to precipitation events. Please refer to **Appendix E** for hydrographs displaying continuous groundwater level data collected through automatic loggers.

Based on manual water level measurements, the seasonal high groundwater elevations noted were 1.44 mbgl.

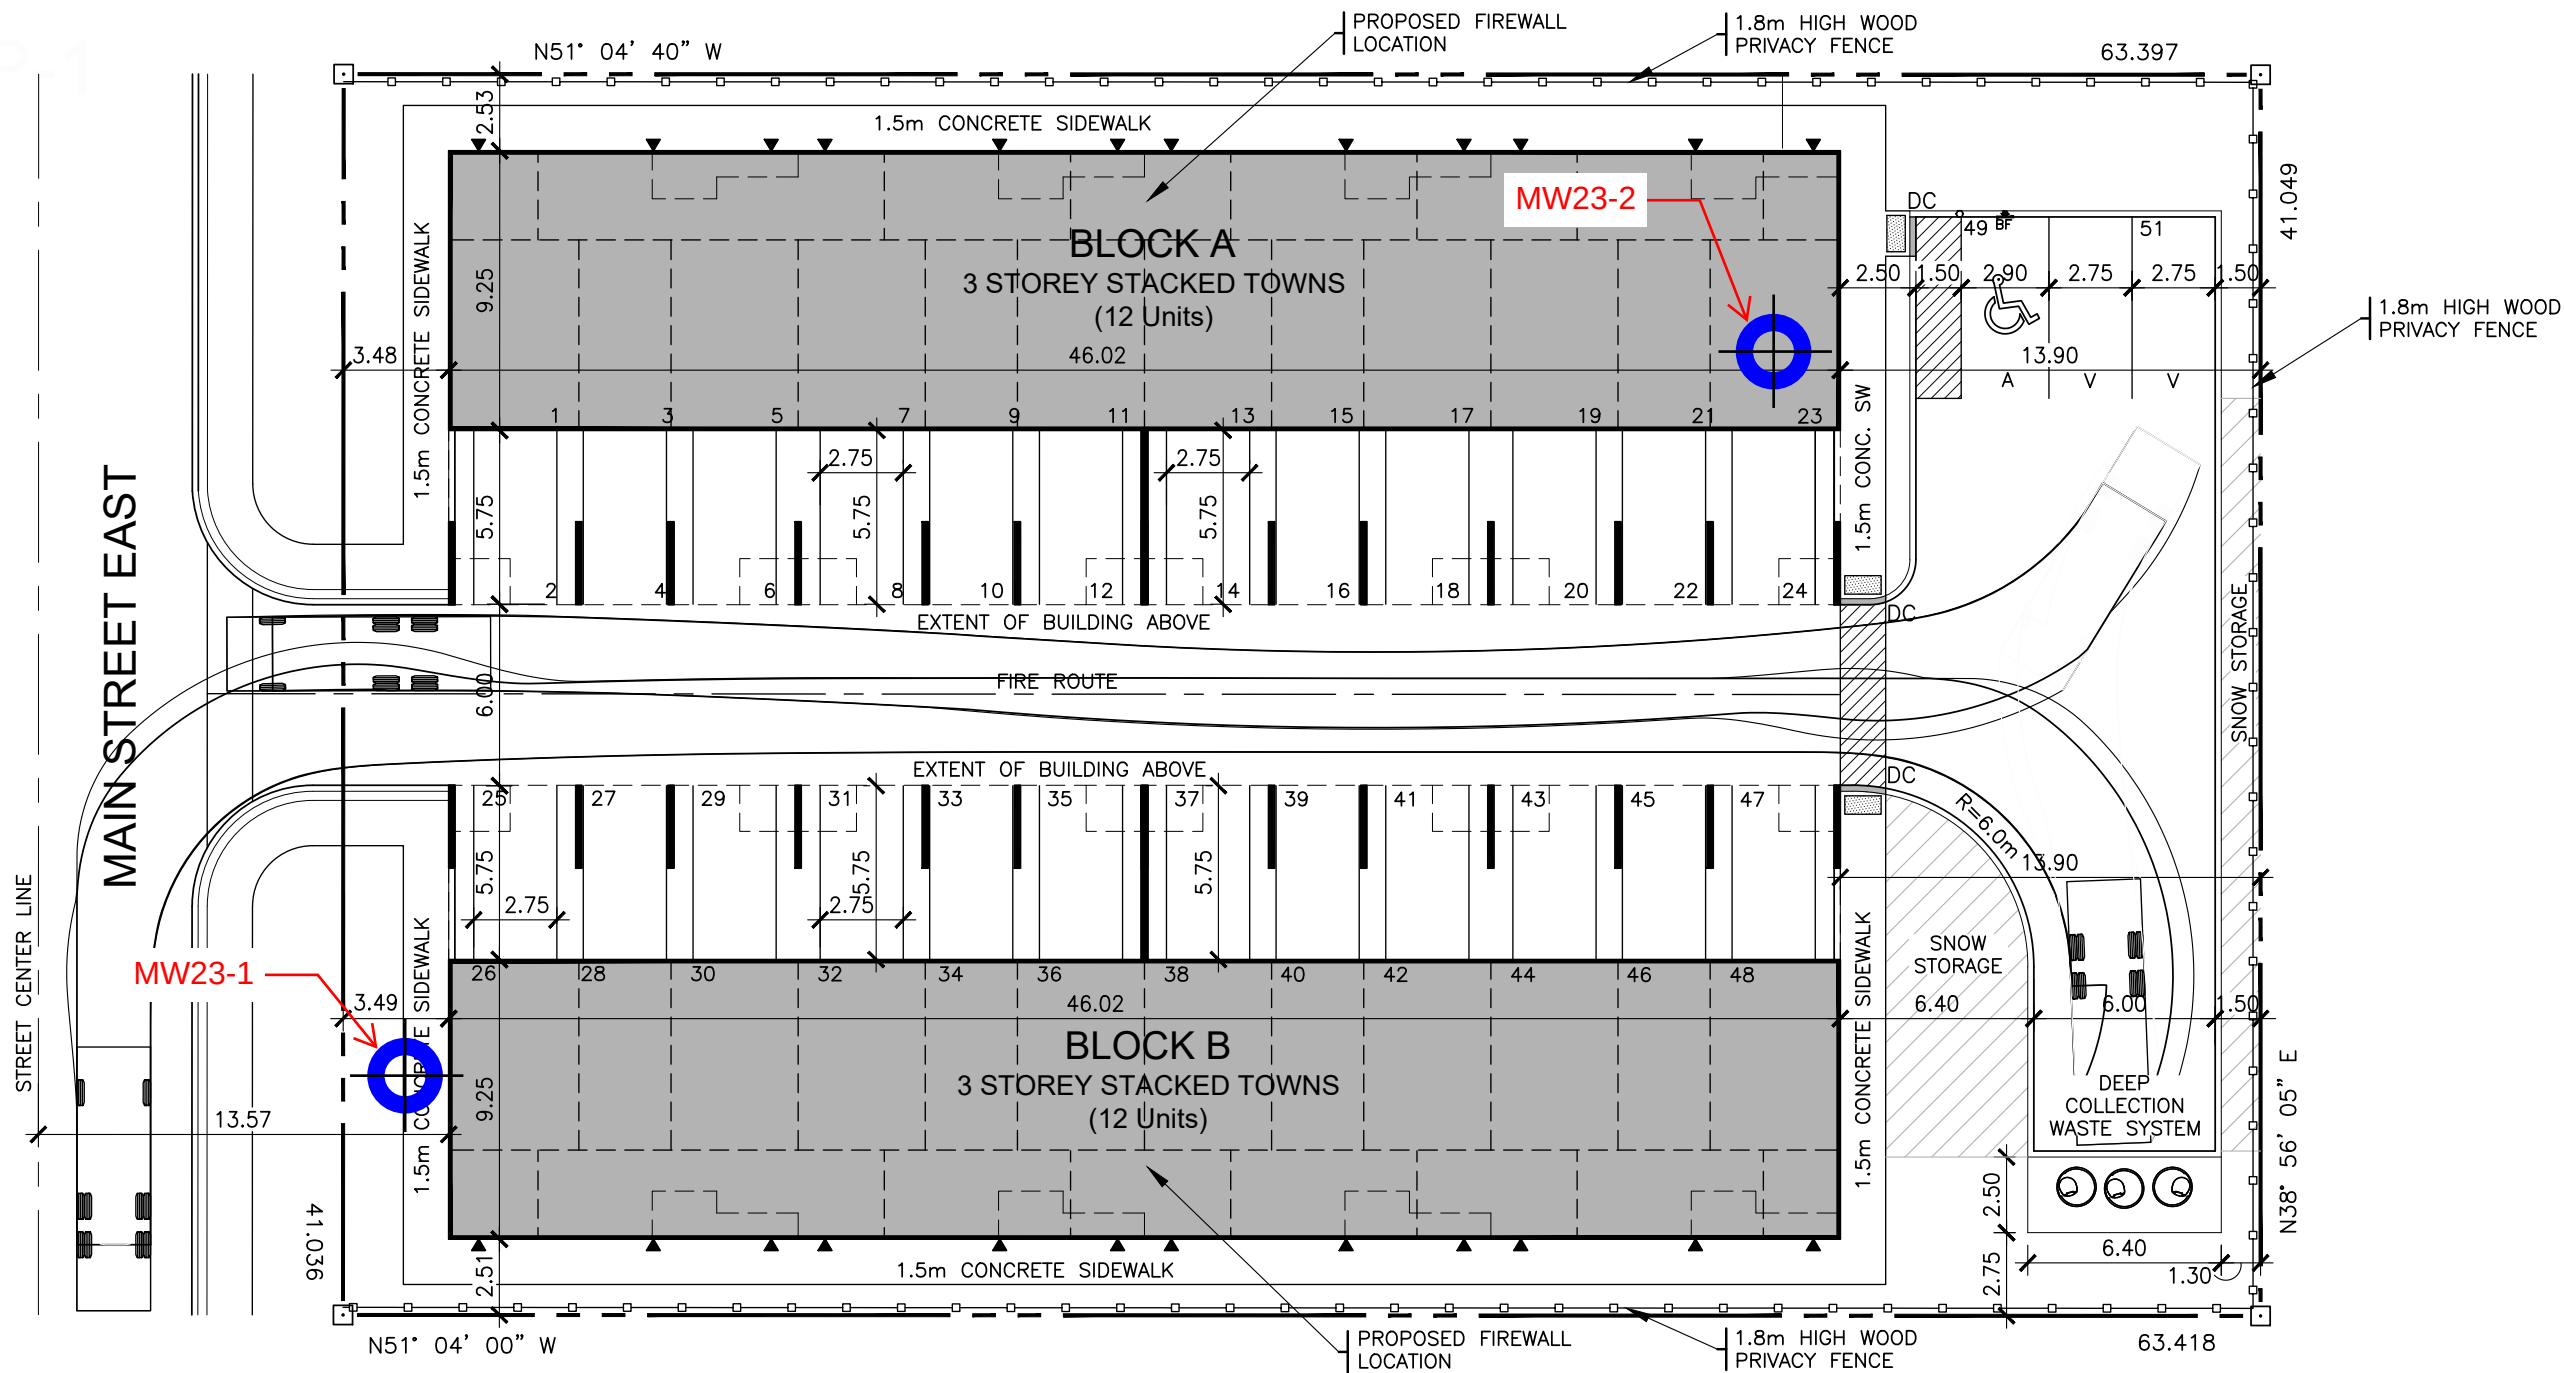
SP-1

Mack TerraPro Cabover 6x4 MRU613 + Wayne Curbtender 31cu yd  
Overall Length 8.721m  
Overall Width 2.438m  
Overall Body Height 3.195m  
Min Body Ground Clearance 0.400m  
Track Width 2.438m  
Lock-to-lock time 6.00s  
Curb to Curb Turning Radius 10.211m
